Construction Analytics

PORTFOLIO OF SELECTED PROJECTS

1.) LARGE REGIONAL LIBRARY IN MISSISSIPPI

2.) TOWNHOUSE IN ASPEN, COLORADO

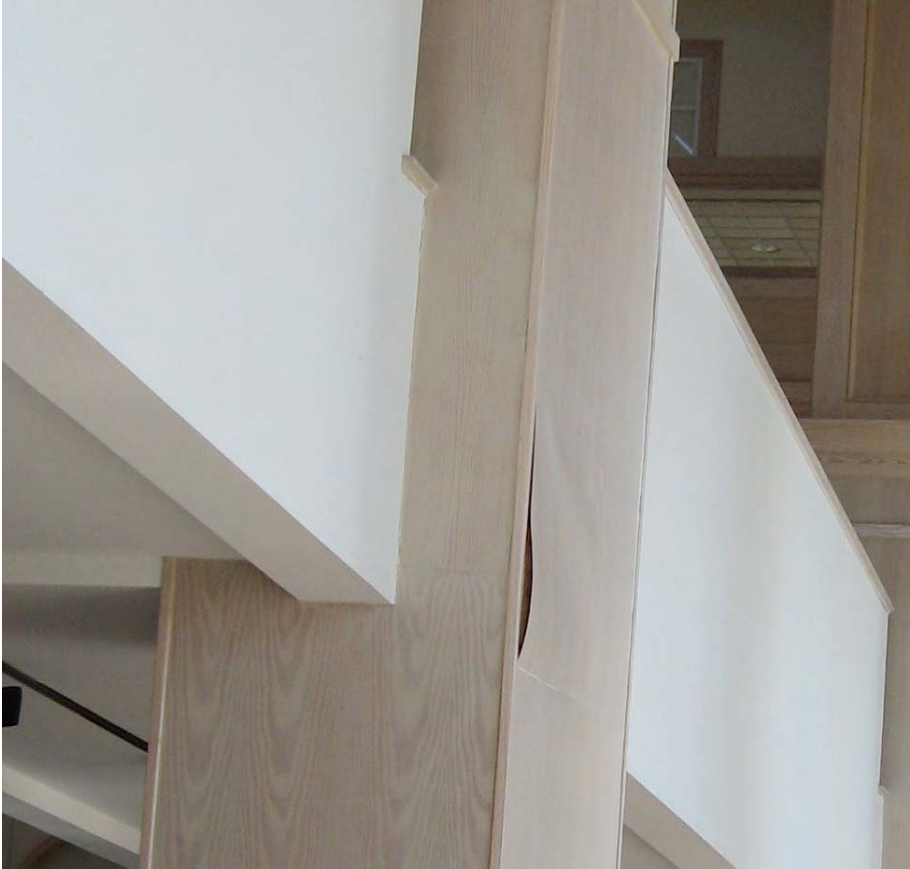
- A.) The roofs of this building had been leaking prior to the incidence of the hurricane. Accordingly, evaluation of the interior water damage required delineation of pre-existing water damage from water damage resultant from the hurricane.
- B.) The clay tile roofing may not have been installed in accordance with specifications, thus predisposing the roofing to damage which would not otherwise have occurred. This posed a subrogation issue.

Millwork Water Damage Precedent to Hurricane

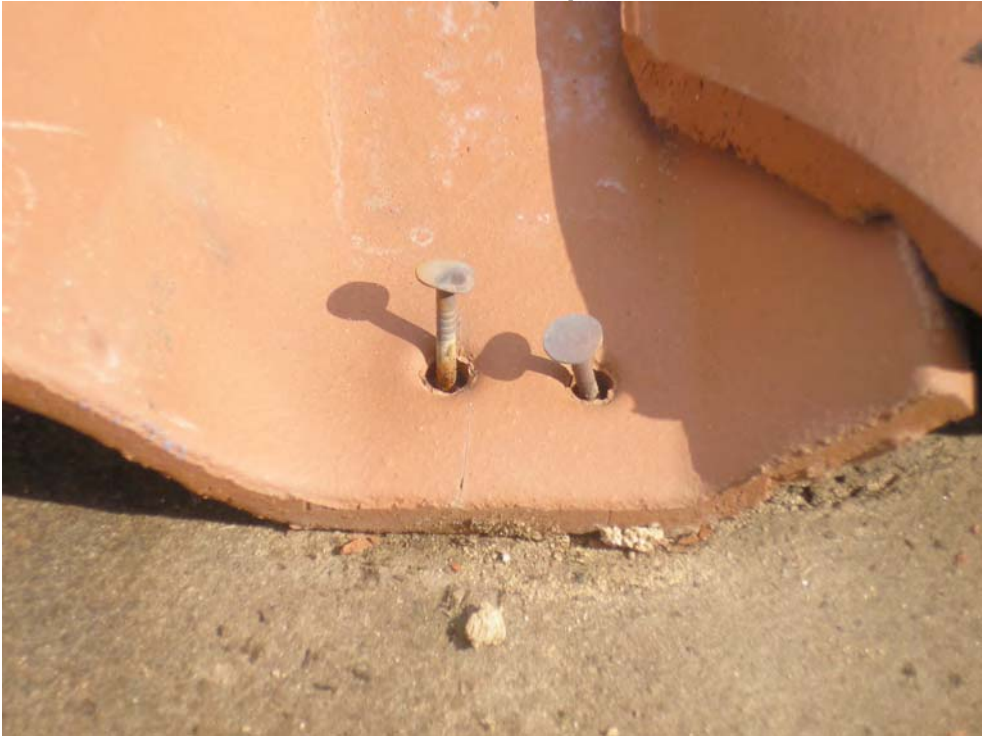
Roof Tile Attached With Non-specification Fasteners

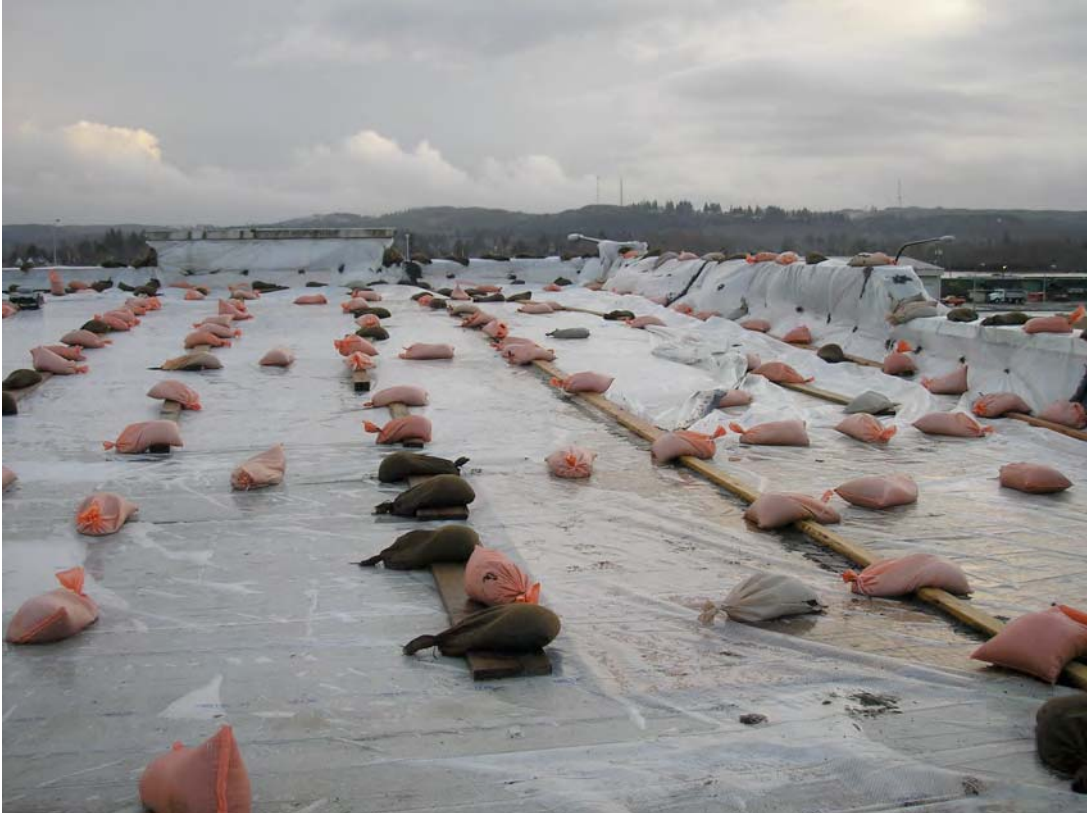
- B.) Insured did not seek out other contractors to effect temporary weather sealing of the roof after several attempts by the local contractor failed to stop water infiltration. Insured was advised of other contractors who could perform this work, but they were not retained.

Second Temporary Roof In Place

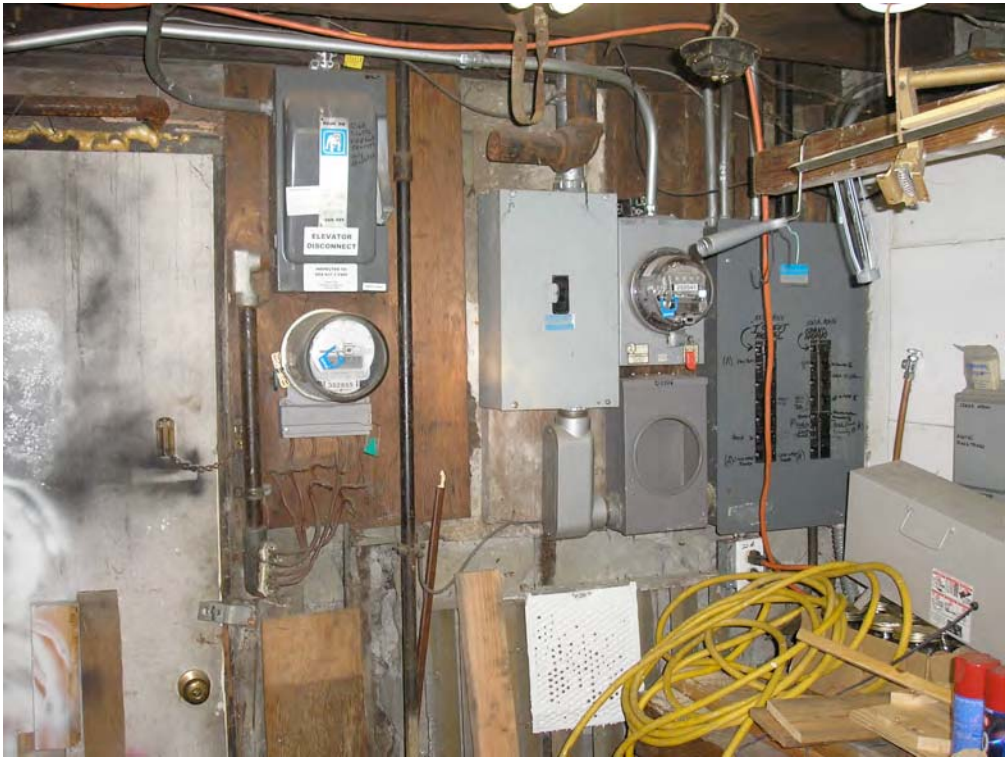
Existing Old & New Electrical Wiring Necessitated Electrical Code Upgrades
